LEVEL IV  
**AMPHIBIOUS LAKE DAM**  
**NJ 00457**

**PHASE 1 INSPECTION REPORT  
NATIONAL DAM SAFETY PROGRAM**

June, 1979

AMPHIBIOUS LAKE DAM (NJ00457)

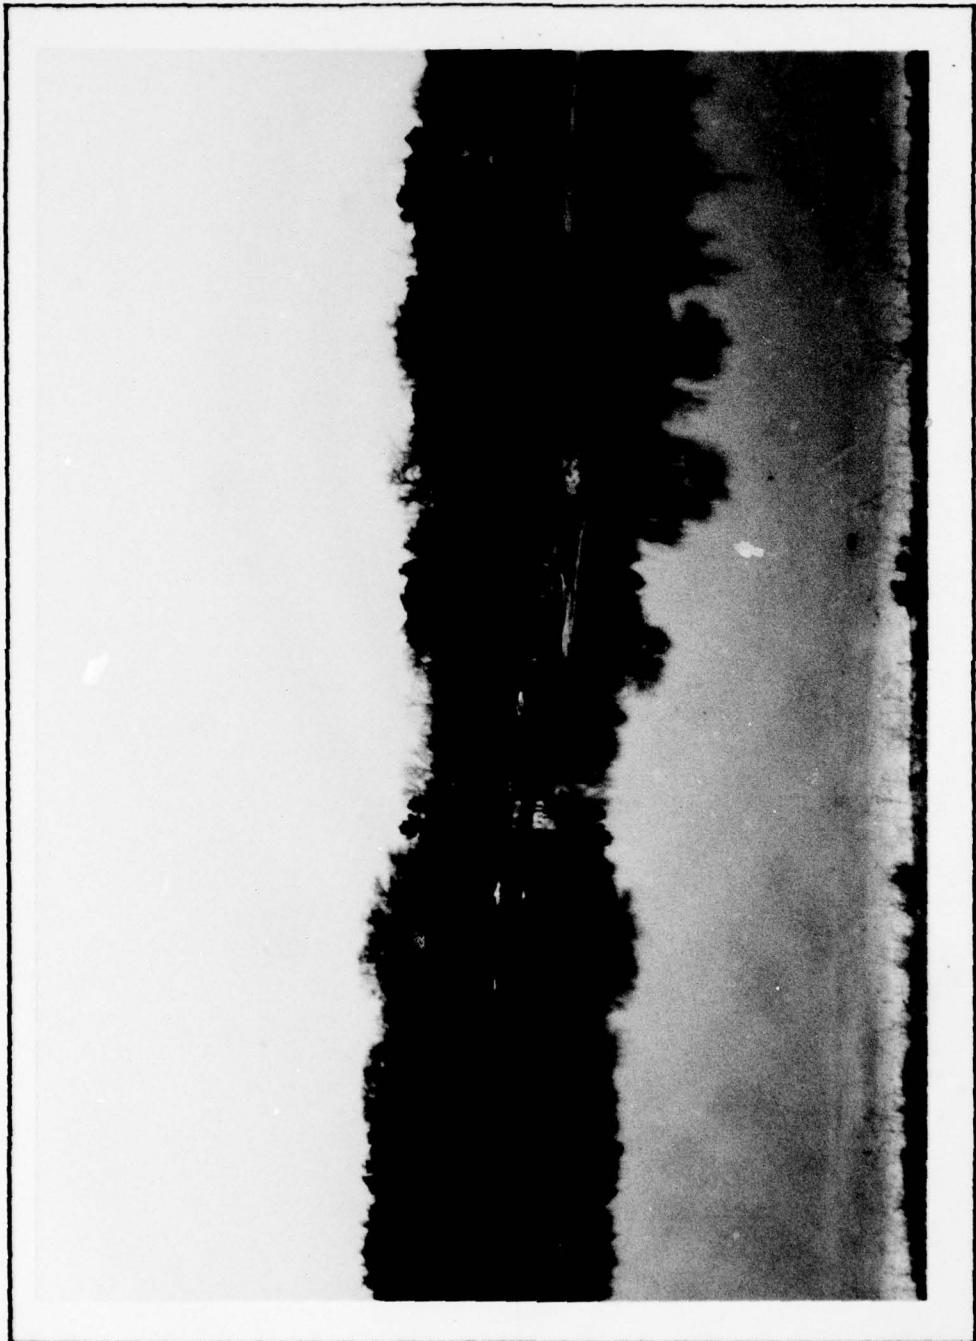
OVERVIEW  
AMPHIBIOUS LAKE DAM, BURLINGTON COUNTY, NEW JERSEY  
4/11/79

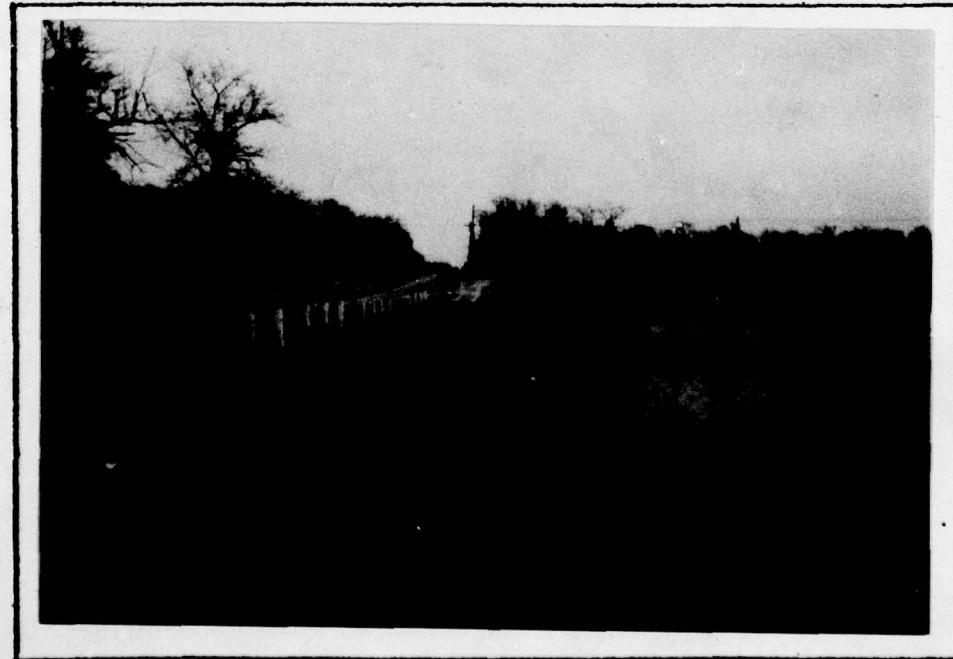
UPSTREAM FACE AND THE TOP OF THE DAM  
FROM THE LEFT ABUTMENT 4/11/79
